ROYAL COMMISSION
QUEBEC BRIDGE INQUIRY
REPORT

REPORT ON DESIGN OF QUEBEC BRIDGE
BY
C. C. SCHNEIDER

The Royal Commission appointed by commission dated the thirty-first day of August, A.D. 1907, to inquire into the cause of the collapse of the Quebec bridge, begs to present its report as follows:—

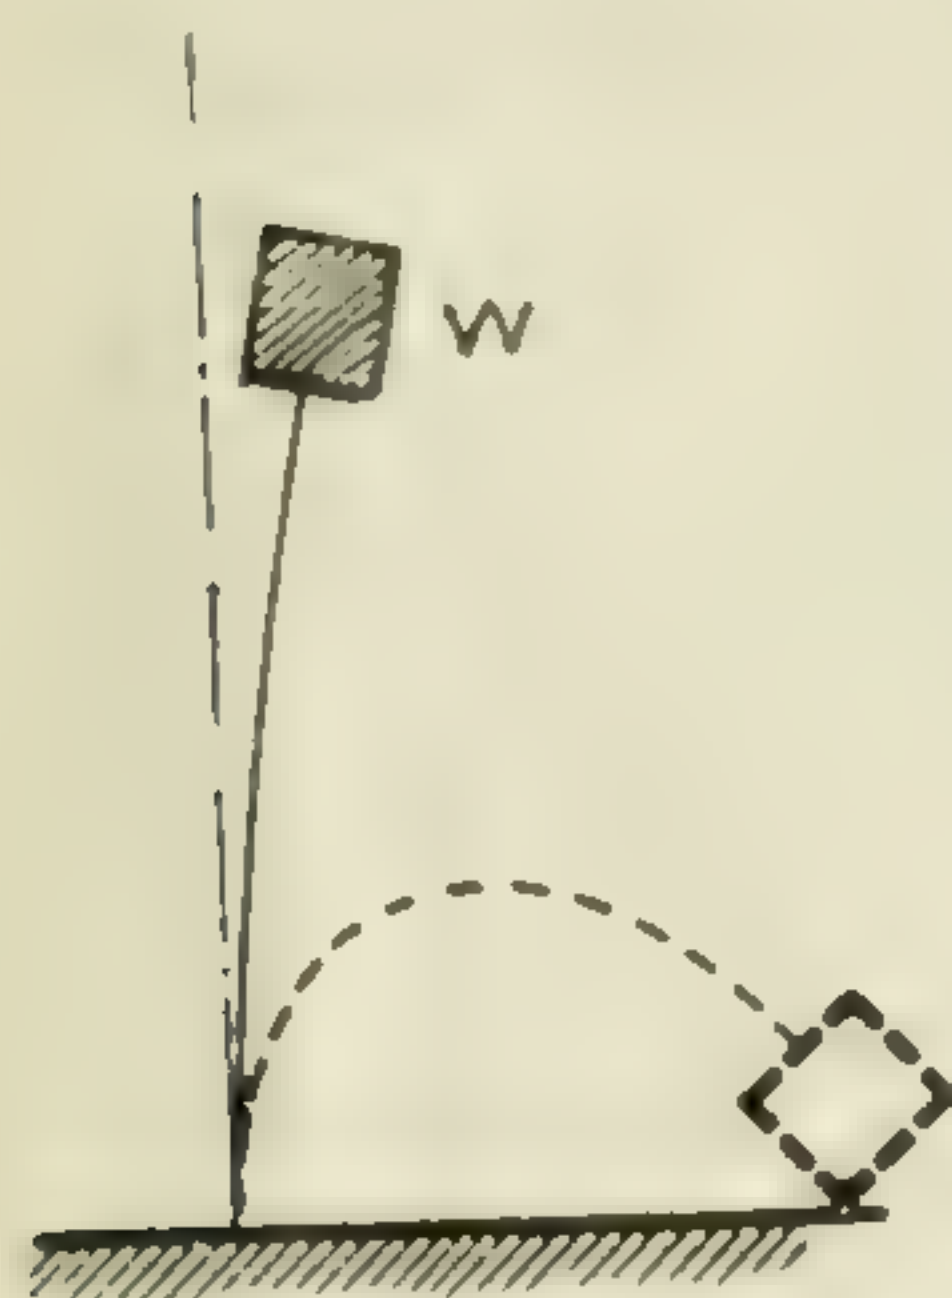
Fig. 1

Perhaps the clearest conception of buckling can be obtained by considering it as the result of unstable equilibrium between the external and internal forces. Assuming a steel spring (Fig. 1) rigidly fixed at the bottom, and loaded at the top with a weight W , then the spring will slightly deflect laterally, but will remain in equilibrium. If W is gradually increased, a condition will be reached where equilibrium is no more possible, and the weight will drop suddenly. The spring has lost its supporting power at this moment of instability, but the weight may go to the bottom without producing any excessive strains in the spring.

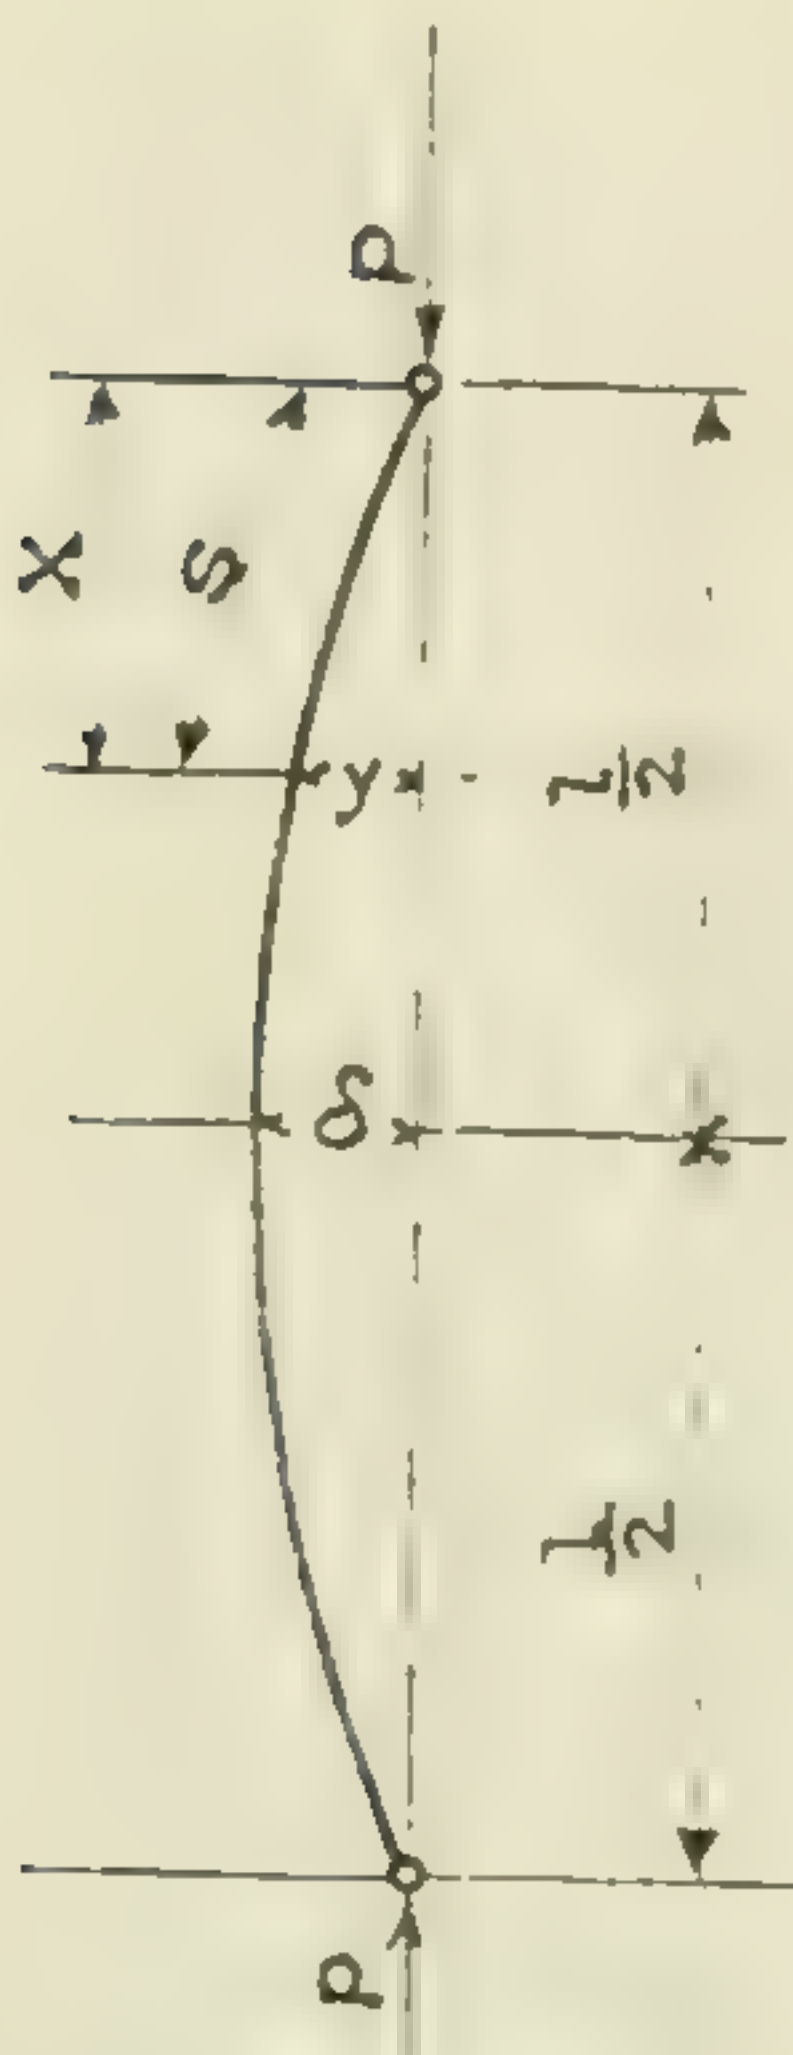
Fig. 2

Let it be assumed that an elastic column with hinged ends free to move in the direction of its original axis, and subjected to an axial load P , has been deflected laterally (see fig 2). Neglecting the shortening of the column and the influence of the shearing strains, and assuming $s=x$, the elastic line is represented by the differential equation

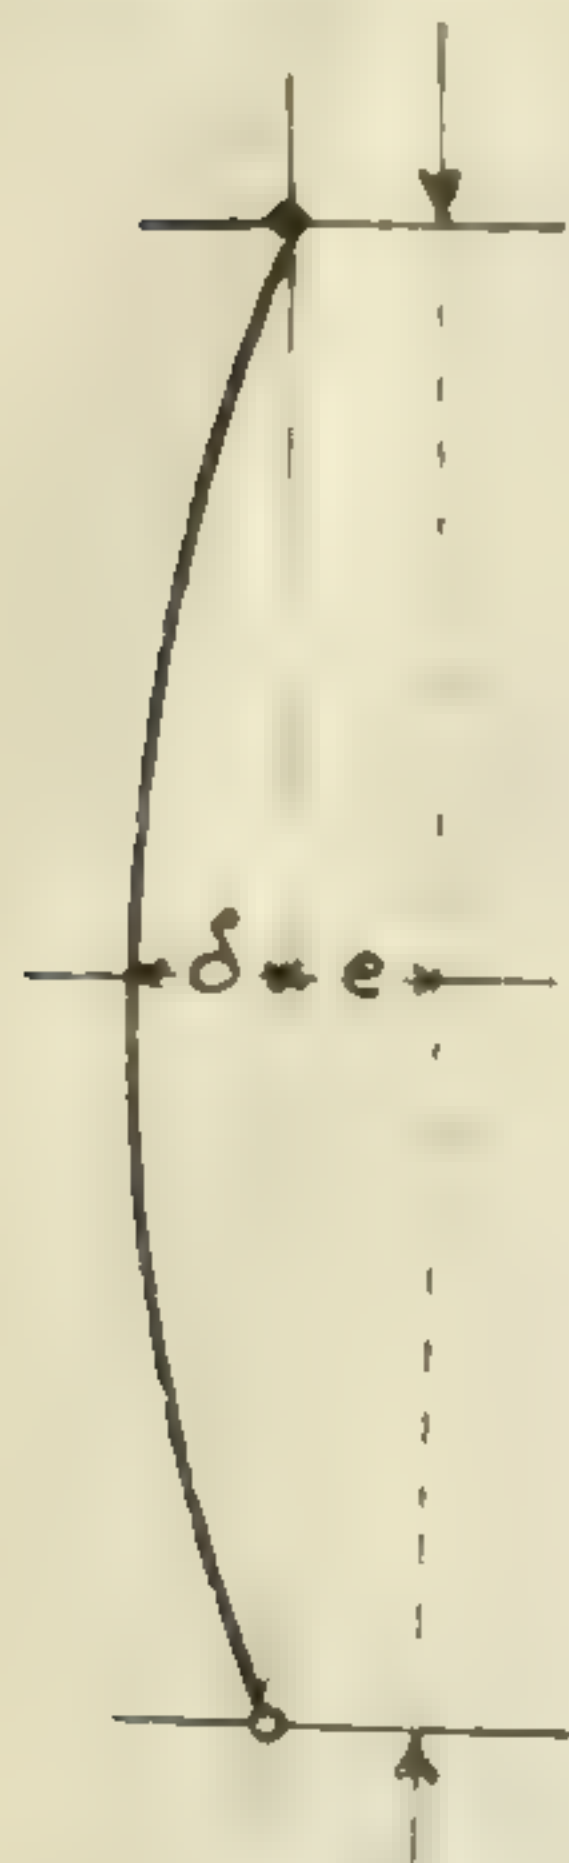
Fig. 3

In formulae (3), (4) and (5), the initial eccentricity ' e ' (fig. 3) has been assumed negligible as compared with the deflection δ . Investigation of the formula given on page 191 for eccentric loading shows that any load P , even below P_0 , can produce deflection; but if the eccentricity ' e ' is small, the buckling load will be only slightly smaller than P_0 , although the maximum fibre strain produced thereby may be higher than the buckling strain. This is another reason for regarding P_0 as the actual buckling load. A greater initial eccentricity will reduce the buckling load by giving fibre strains above the limits of safety.

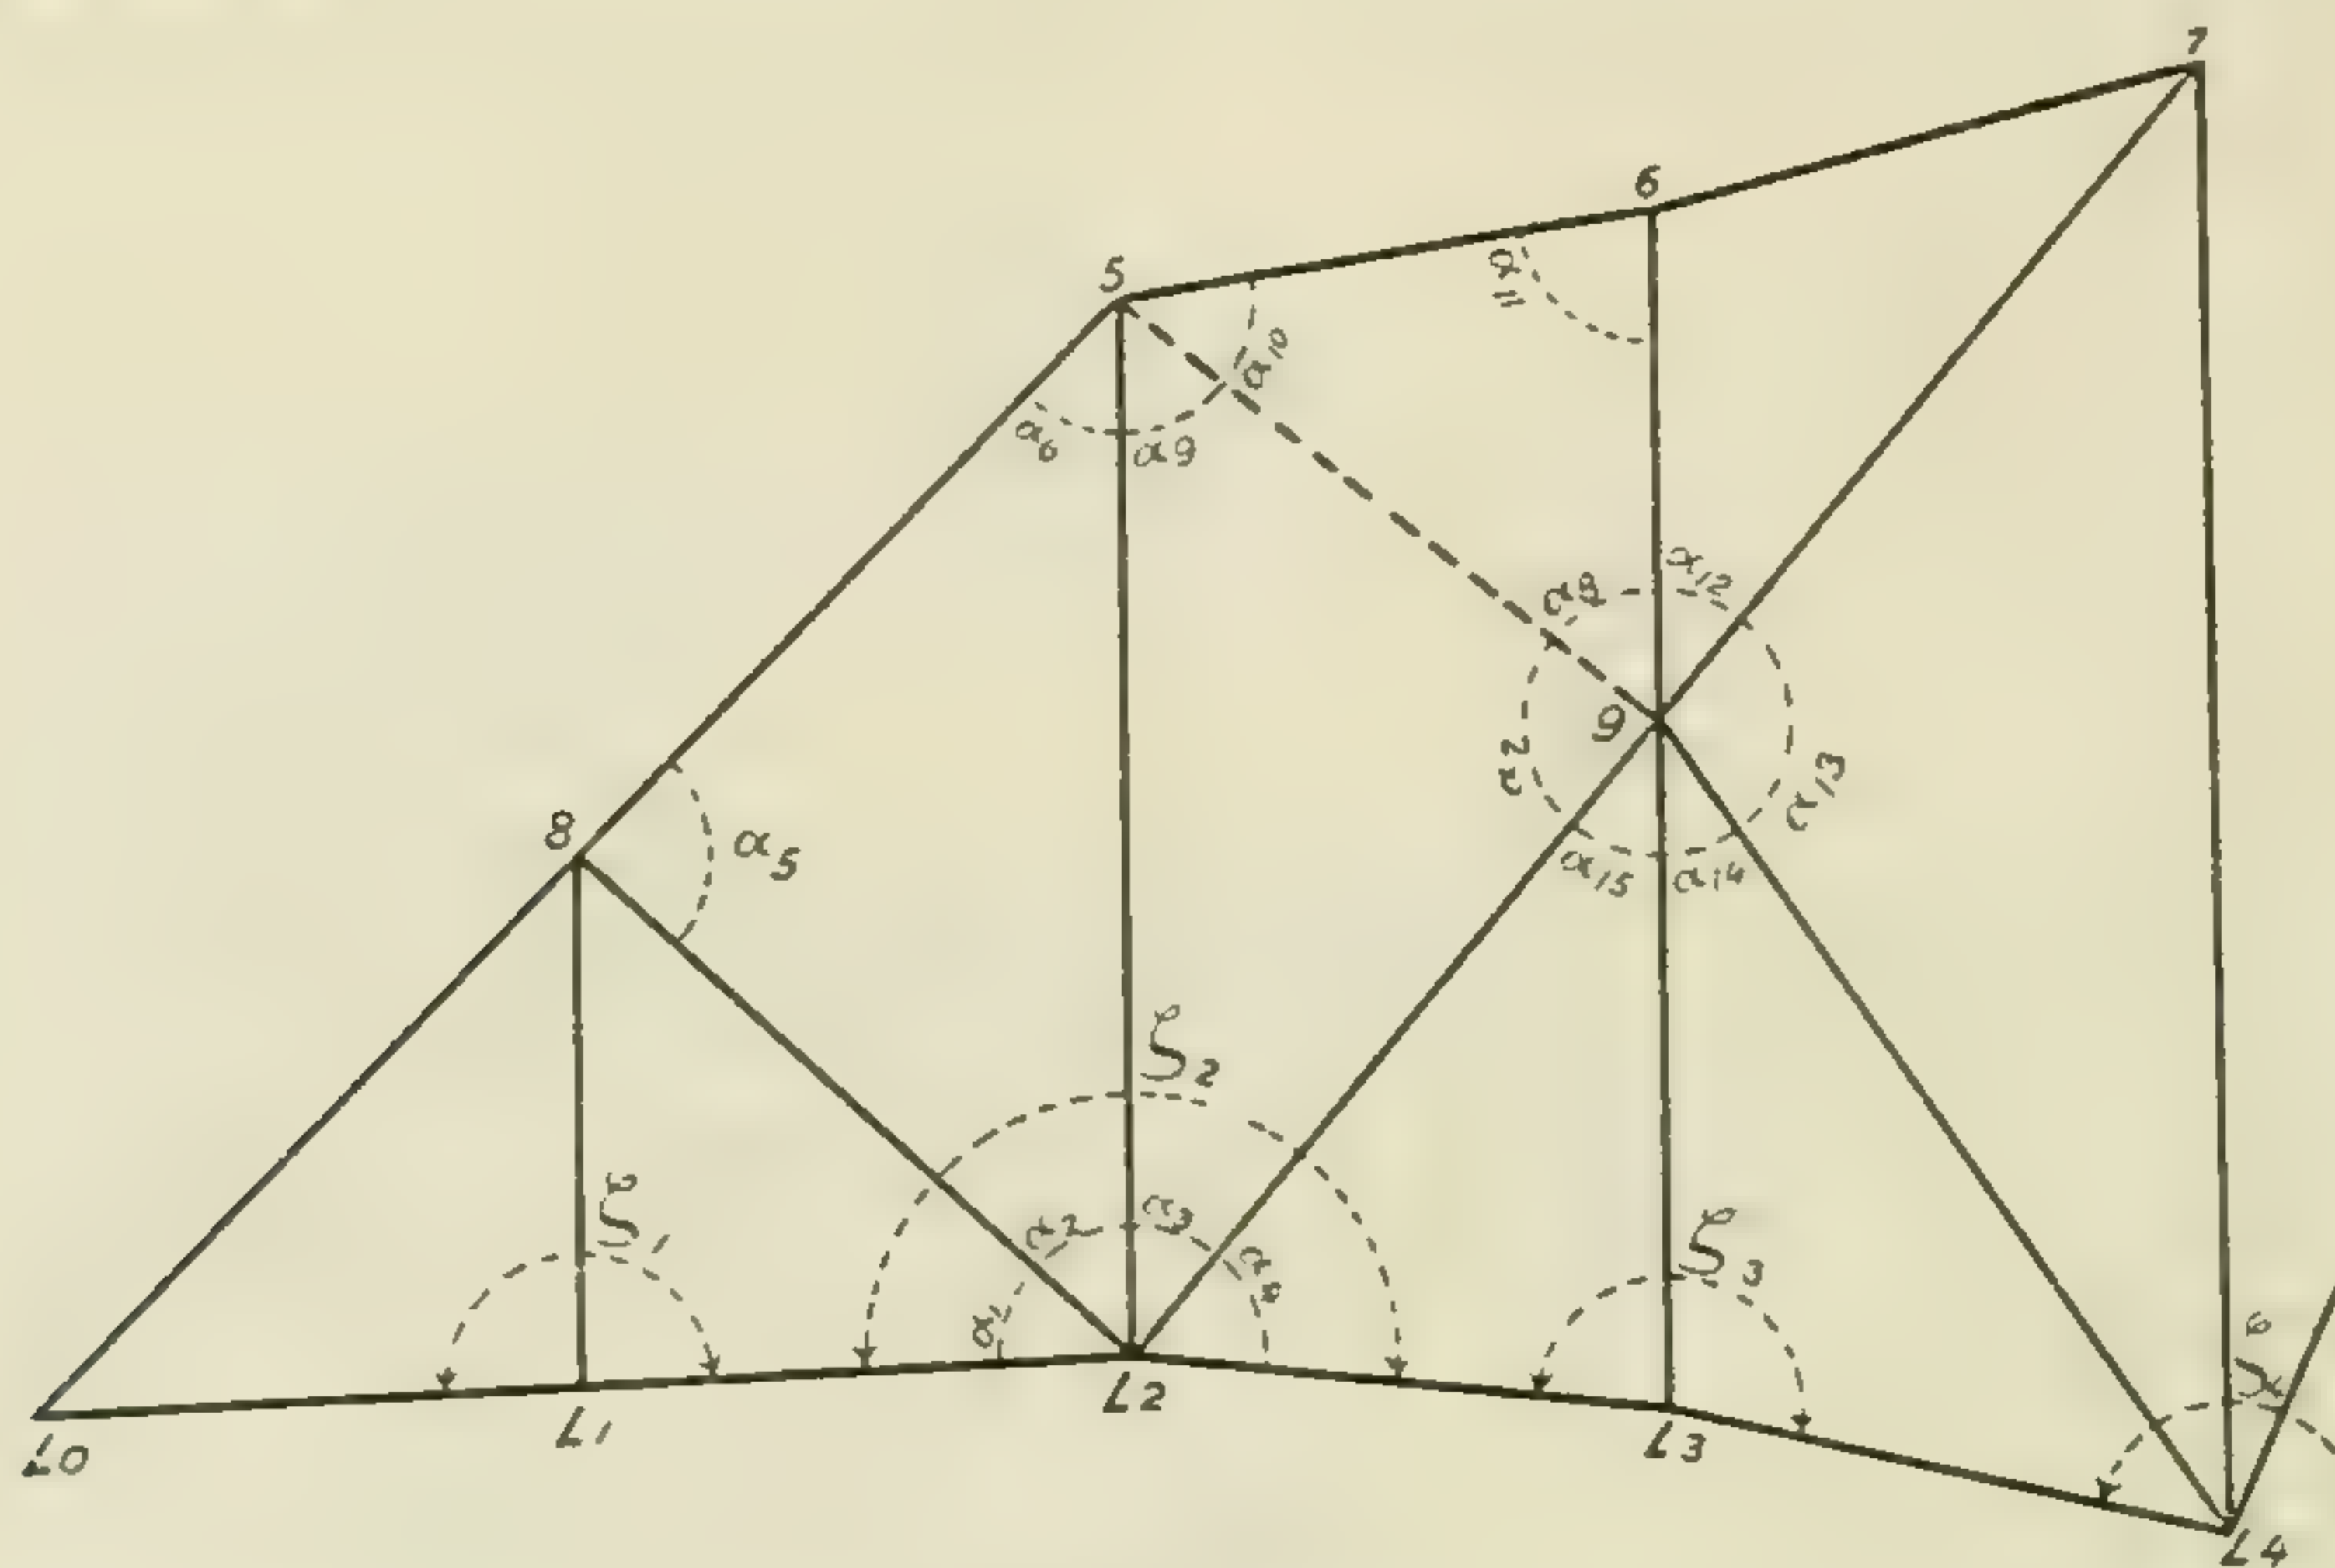
Fig. 1.

The lower chord of the truss is continuous over the entire length of anchor and cantilever arms; while all the other members are pin-connected. For the present, the friction of the pins will be neglected; all the members connected to the lower chord will, therefore, be considered as turning freely at their ends and receiving no secondary strains under any load. If the lower chord sections, like the other members, were free to turn at their ends, the original angles $\zeta_1, \zeta_2, \zeta_3$ (see Fig. 1) between two adjacent sections would change under a given load to $\zeta_1 + \Delta\zeta_1, \zeta_2 + \Delta\zeta_2, \zeta_3 + \Delta\zeta_3$. The change

$\Delta\zeta_3$ at panel point L_3 is equal to the sum of the changes Δa_1 , Δa_2 , Δa_3 , and Δa_4 of the angles a_1 , a_2 , a_3 , a_4 .

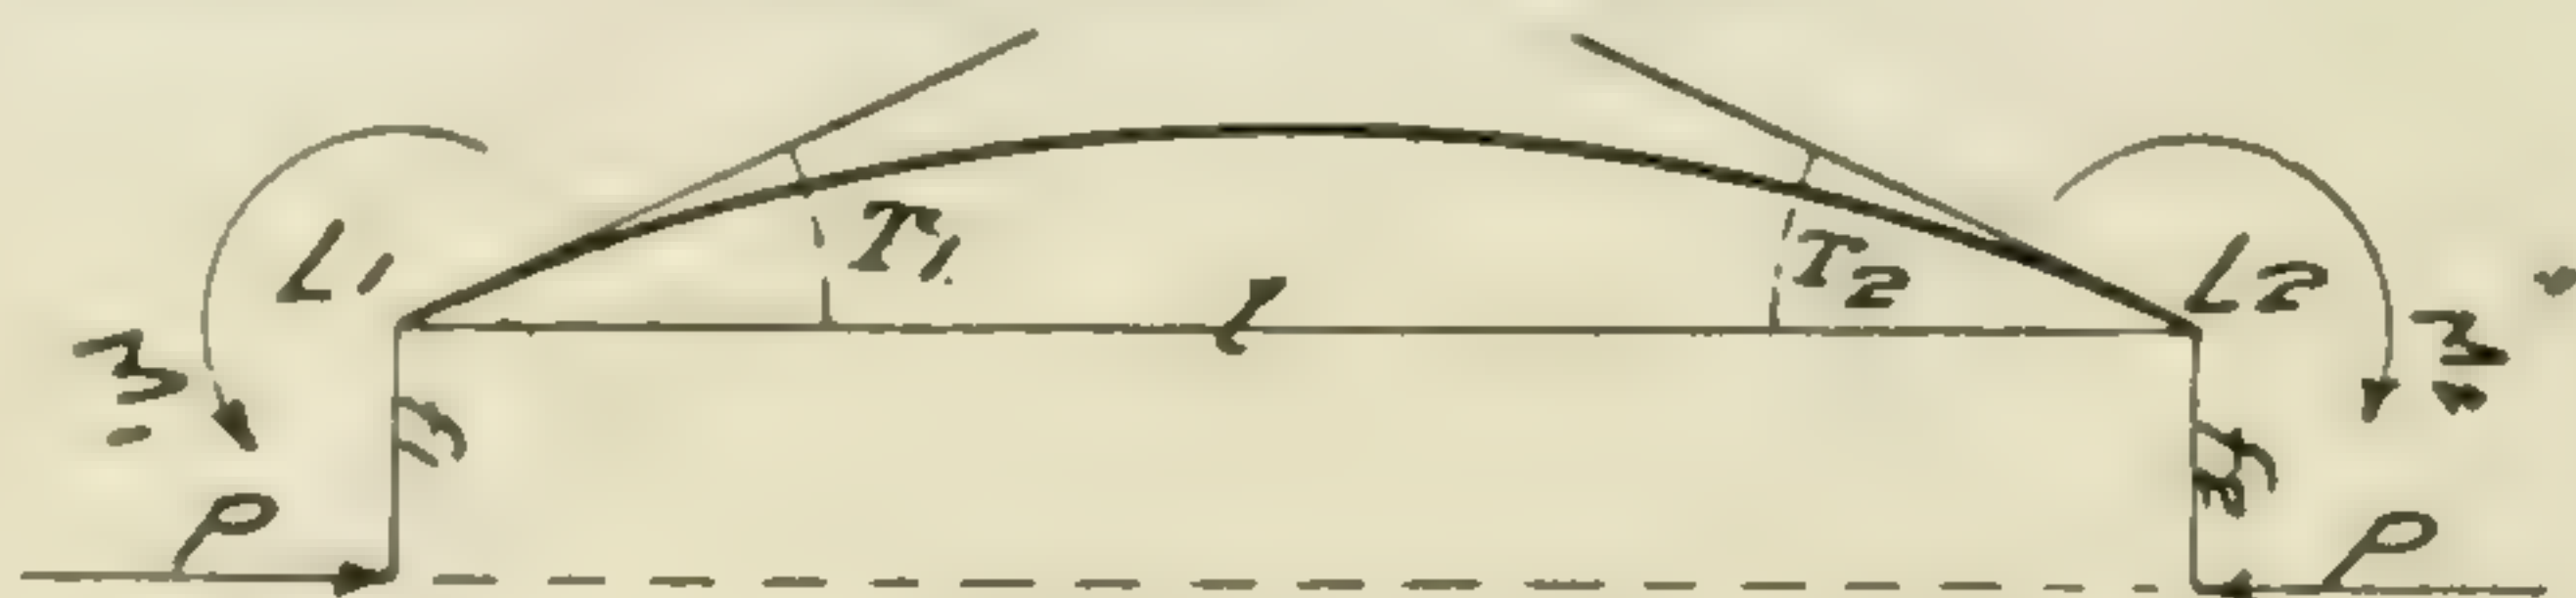
Fig. 2.

This enables use to determine Δa_3 from the triangle 2-5-9. In this way will be determined all the changes $\Delta\zeta$ which would take place under a given load, assuming that the lower chord sections were free to turn at their ends. Owing to the continuity of the chord, these changes in the angles ζ cannot take place without bending the chord. In other words, the forces P at the ends of each bottom chord section are no longer acting axially, but produce bending strains. (See fig. 2.)

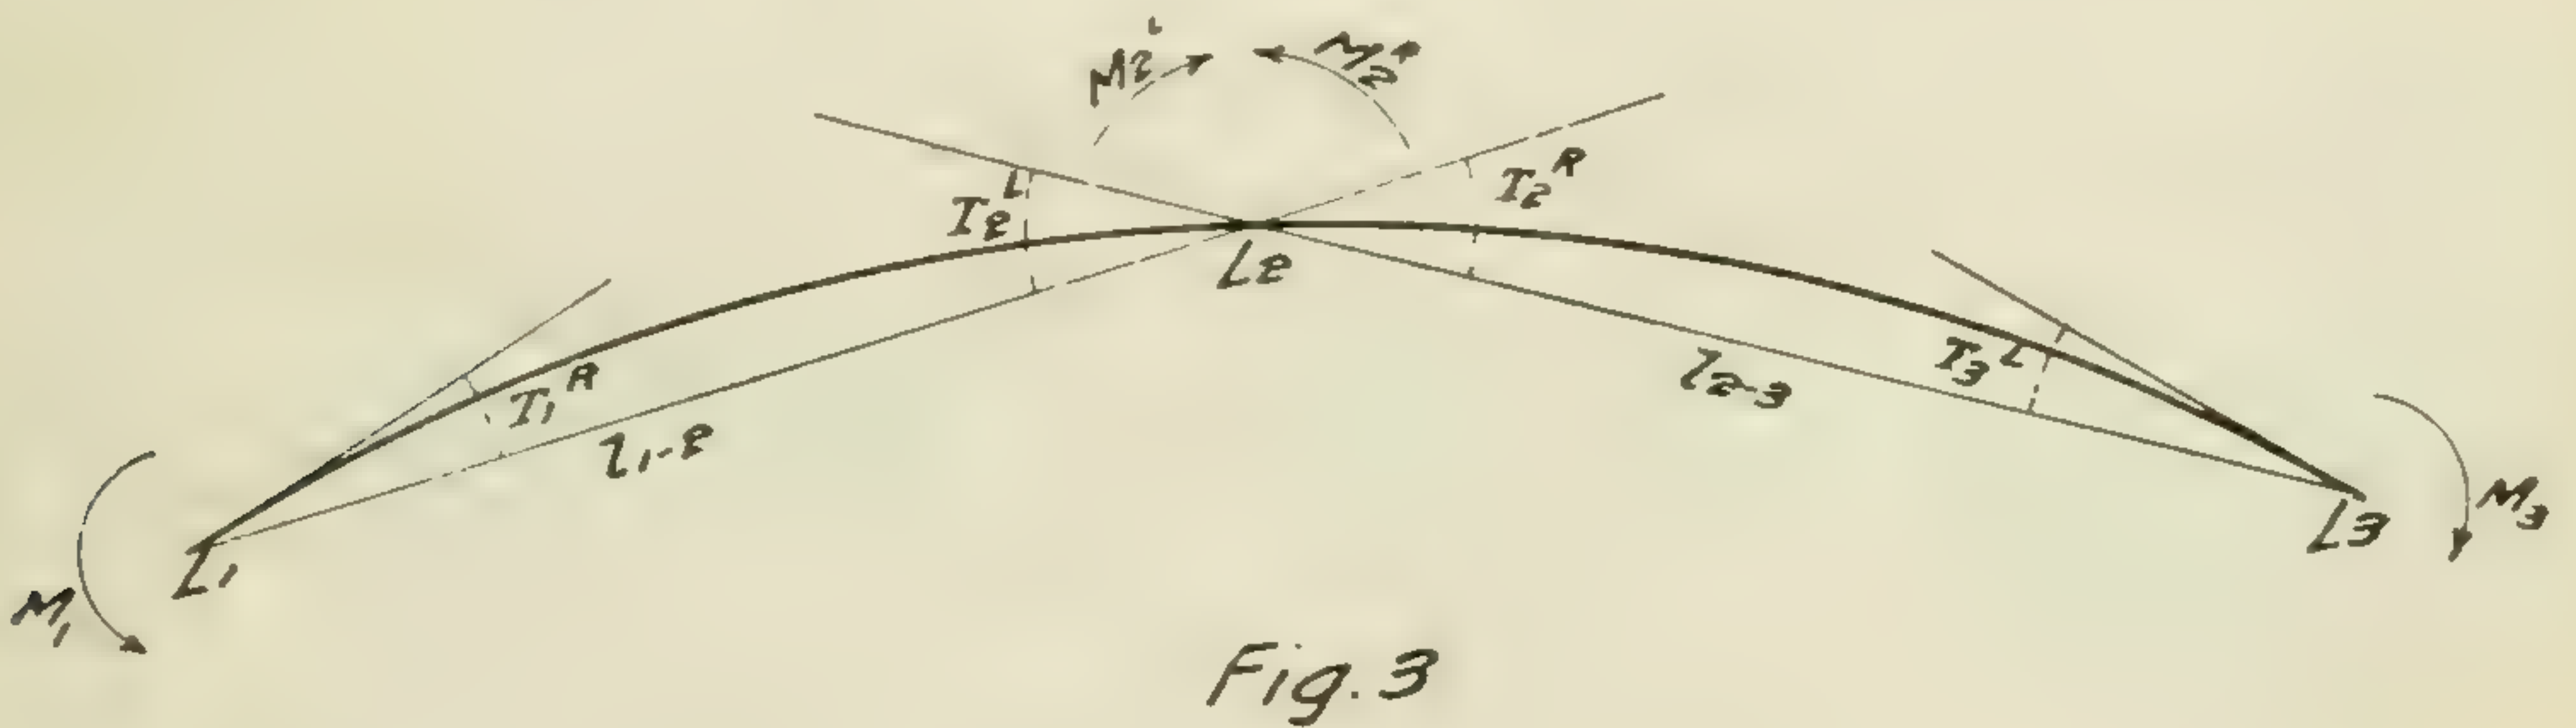
Two adjacent lower chord members $L_1 - L_2$ and $L_2 - L_3$ (fig. 3) will now be considered. In order to have equilibrium, the two moments M_2^L and M_2^R at the panel point L_2 must be equal $= M_2$. The sum of the angles T_2^L and T_2^R must be equal to the deformation $\Delta \zeta_2$ of the angle ζ_2 .
